# ACOUSTICAL RENOVATION OF THE JYVÄSKYLÄ SINFONIA REHEARSAL HALL

H Niemi            AINS Group  
M Kylliäinen     AINS Group  
J Lietzén         AINS Group

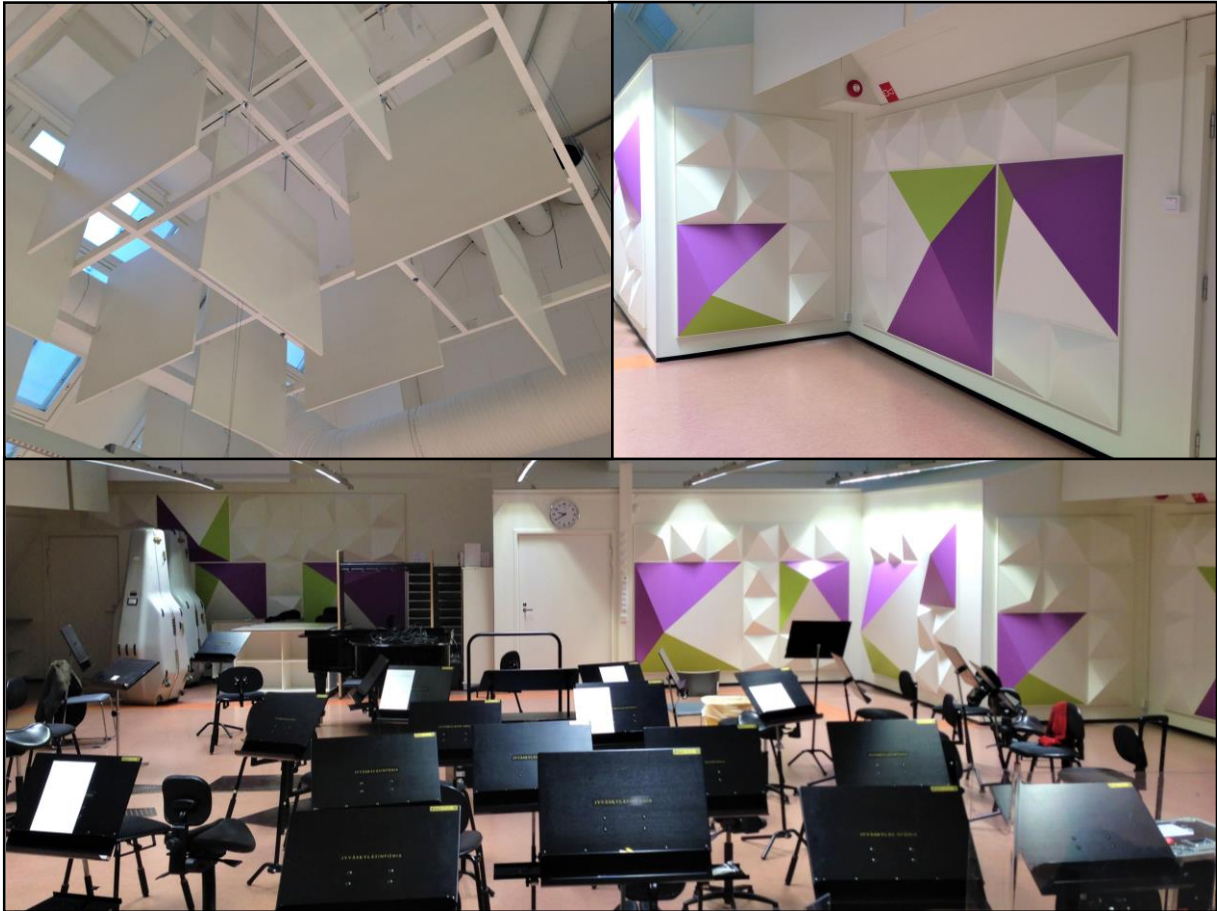
Figure 4: The rehearsal hall after the renovations. The newly mounted ceiling (top left) and wall diffusers (top right) can be seen in the image.

To improve the acoustics of the room, several changes were undertaken to increase the reverberation time without increasing loudness. Volume diffusers consisting of vertical panels arranged perpendicularly in a grid, as described by Arau-Puchades<sup>3,4</sup>, were added. (Fig. 4)

The existing suspended vertical plates backed by mineral wool were removed and 3 additional gypsum boards were added to the inclined side walls, to decrease absorption in the lower frequencies. In the finished room, diffusing pyramid surfaces were added to all the vertical walls below 2,2 m.
